RUBBER CRUMB LOSS ASSESSMENT FROM PLAY AREAS IN THE GREAT BARRIER REEF CATCHMENT

AUSTRALIAN
MARINE DEBRIS INITIATIVE

November 2021

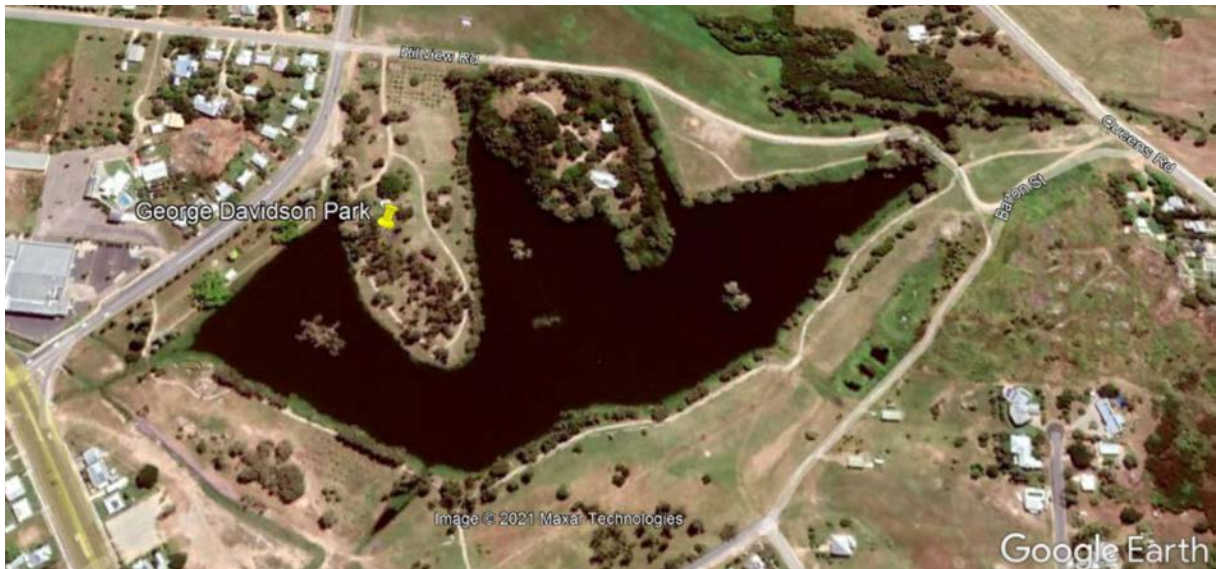
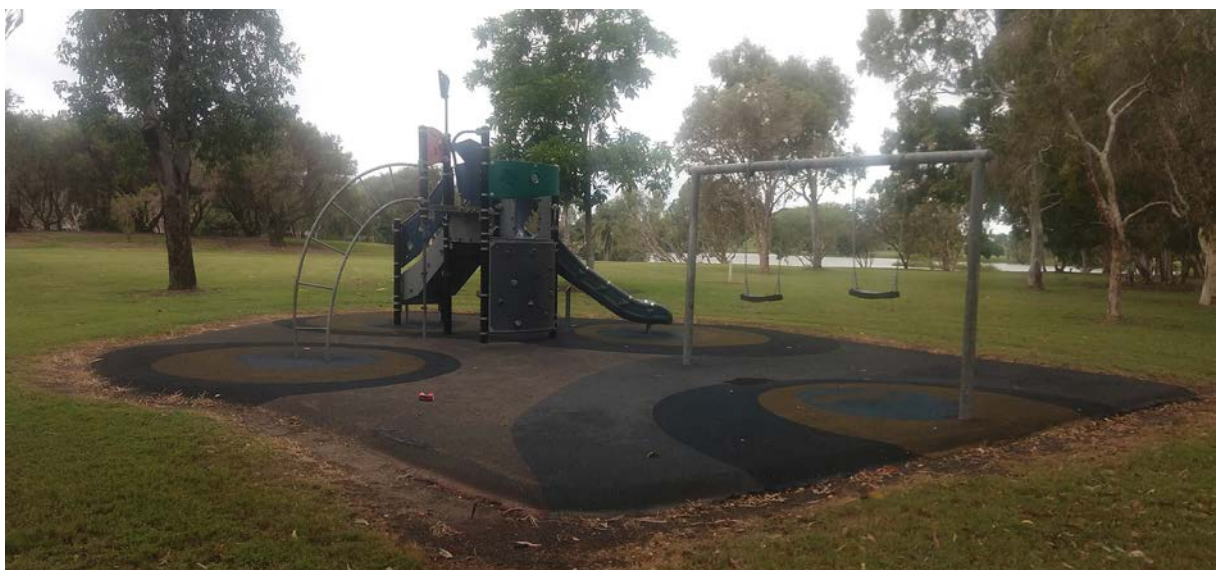
George Davidson Park (AKA Mullers Lagoon Park) play area is 11 m x 8 m containing a swing, slide and climbing equipment. The play area is immediately surrounded by grass and the nearest waterway is Mullers Lagoon, approximately 40 m from the play area. The play surface is approximately 10 years old and made up of light blue, orange/olive, grey and dark blue coloured rubber.

Sampling was conducted on the 25/04/2021. Moderate rainfall occurred (13.2 mm) in the 72 h before sampling. The condition of the play surface was graded as deteriorated with obvious signs of damage. The play area has limited shading. Twelve cores (8 cm diameter x 2 cm depth) were taken at 0 m, 2 m and 4 m away from the play area.

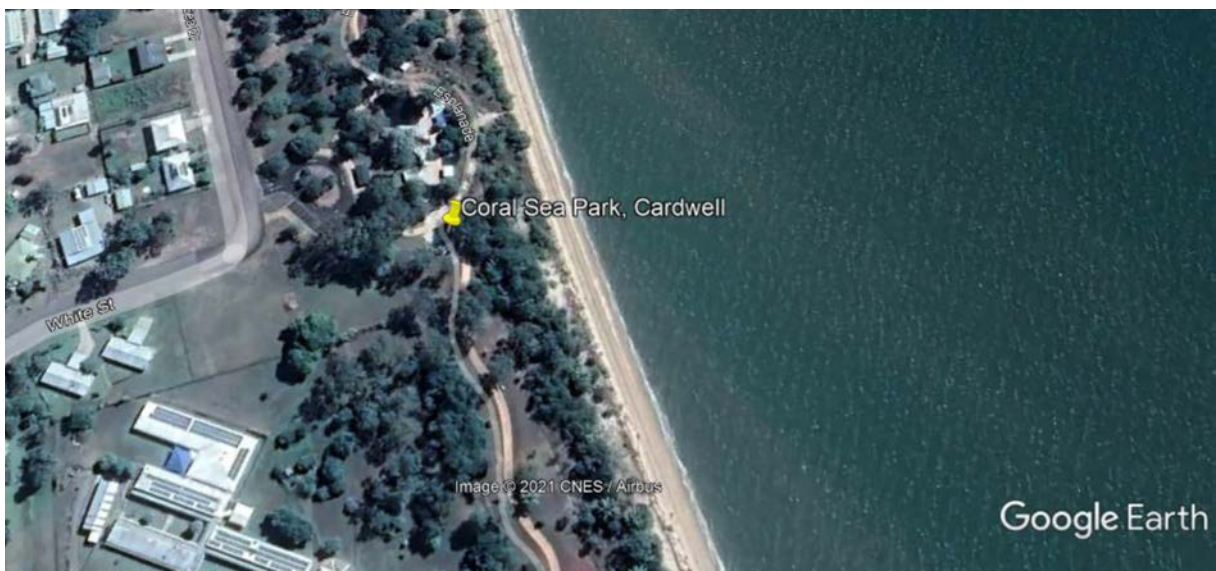
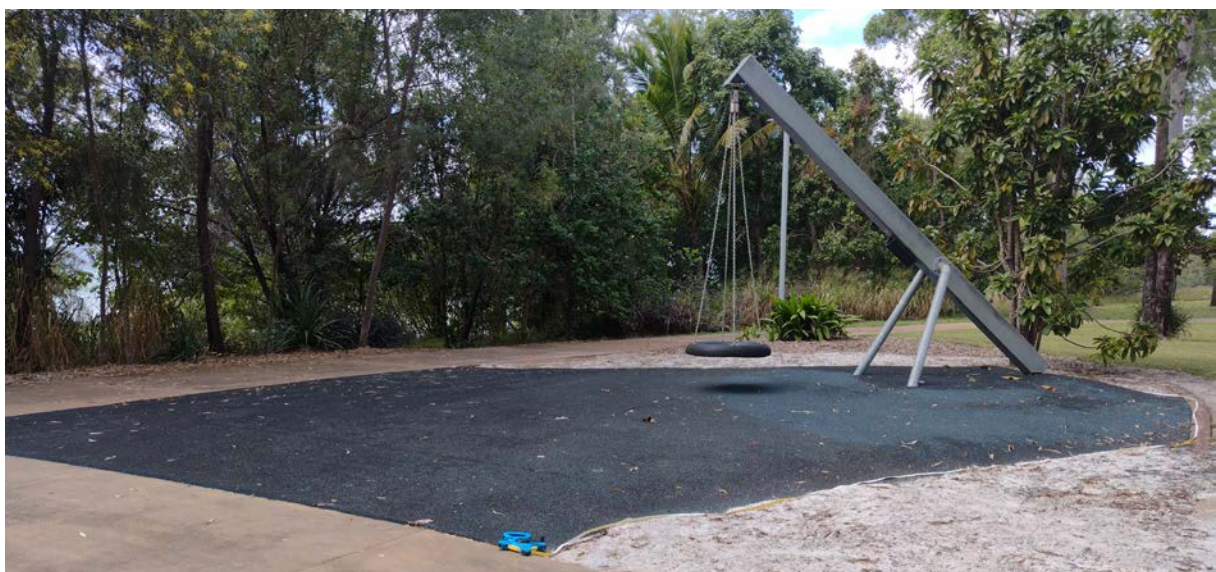
Coral Sea Park play area is 20 m x 18 m containing a swing and seat is only one of a selection of play areas in the park. The area is immediately surrounded by concrete path (30 %), sand (30 %), bark (20 %) and grass (20 %) and is 40 m from the beach. The play surface is approximately 8 years old and made up of predominantly dark blue coloured rubber.

Sampling was conducted on the 30/05/2021. Minimal rainfall occurred (0.2 mm) in the 72 h before sampling. The condition of the play surface was graded as deteriorated with obvious signs of damage. The play area has limited shading. Twelve cores (8 cm diameter x 2 cm depth) were taken at 0 m, 2 m and 4 m away from the play area from the sand/bark/grass areas.

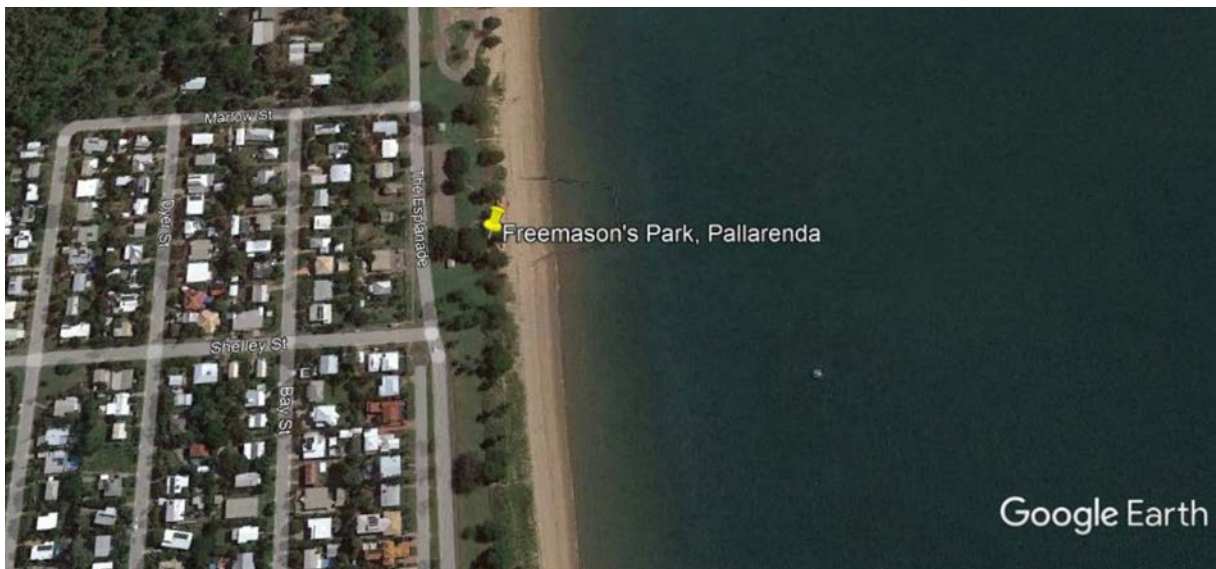
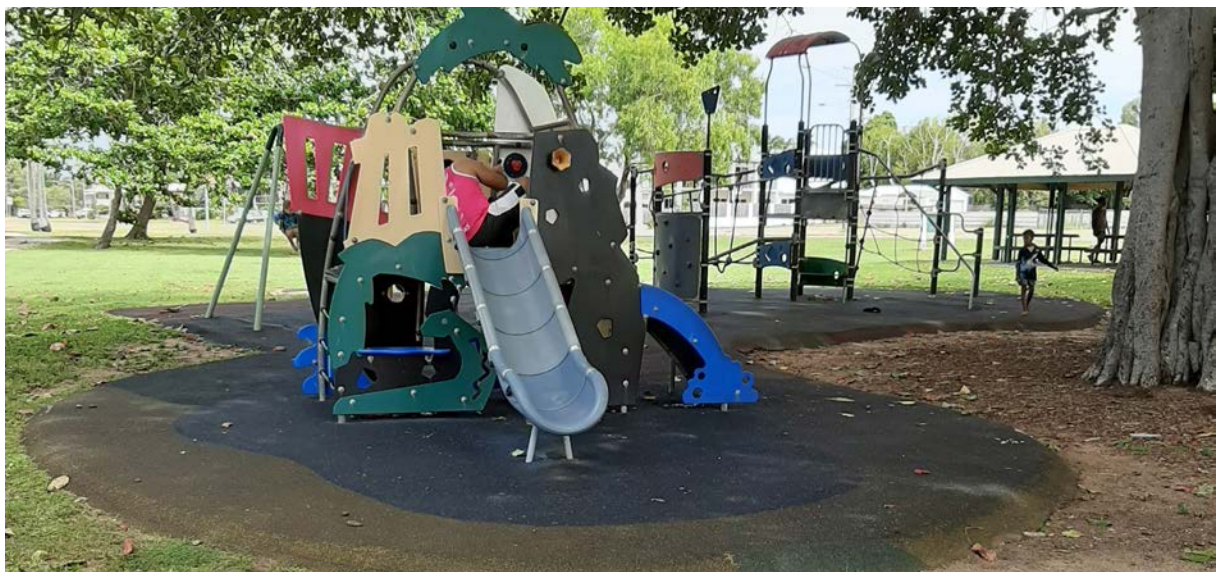
Freemasons play area is 32 m x 6 m containing slides and climbing equipment. The area is immediately surrounded by grass (50 %), exposed ground (45 %) and a path along one side (5 %). The park runs along the beach with the play area 28 m from the water. The play surface is approximately 10 years old and made up of black, red and dark blue coloured rubber.

Sampling was conducted on the 17/04/2021. No rainfall occurred in the 72 h before sampling. The condition of the play surface was graded as deteriorated with obvious signs of damage. The play area is part shaded by a large tree. Ten cores (8 cm diameter x 2 cm depth) were taken at 0 m, 2 m and 4 m away from the play area.

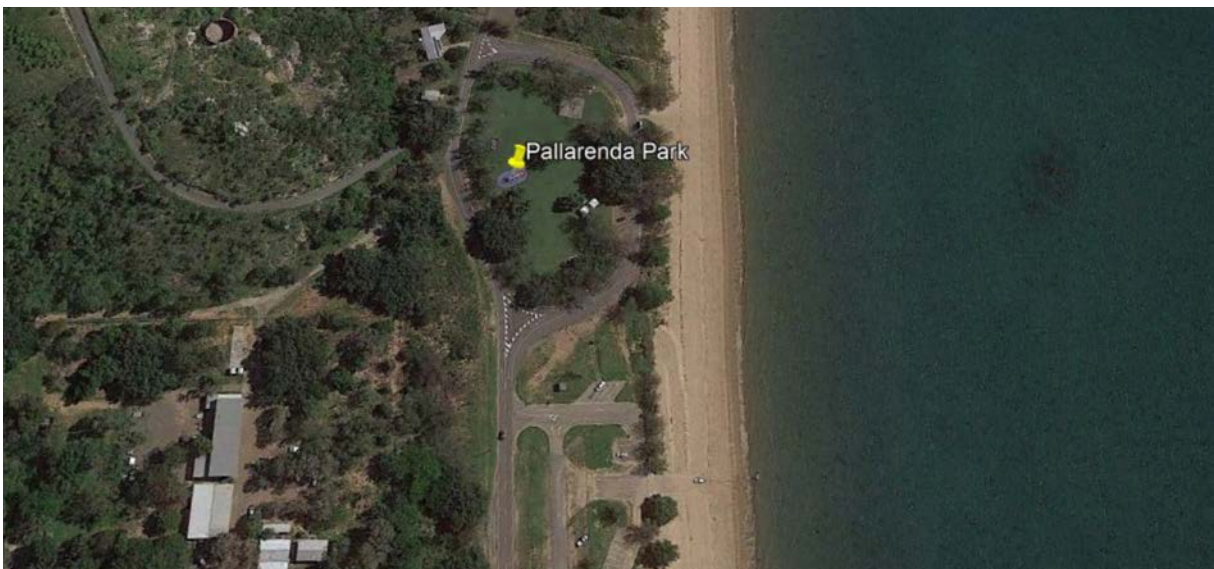
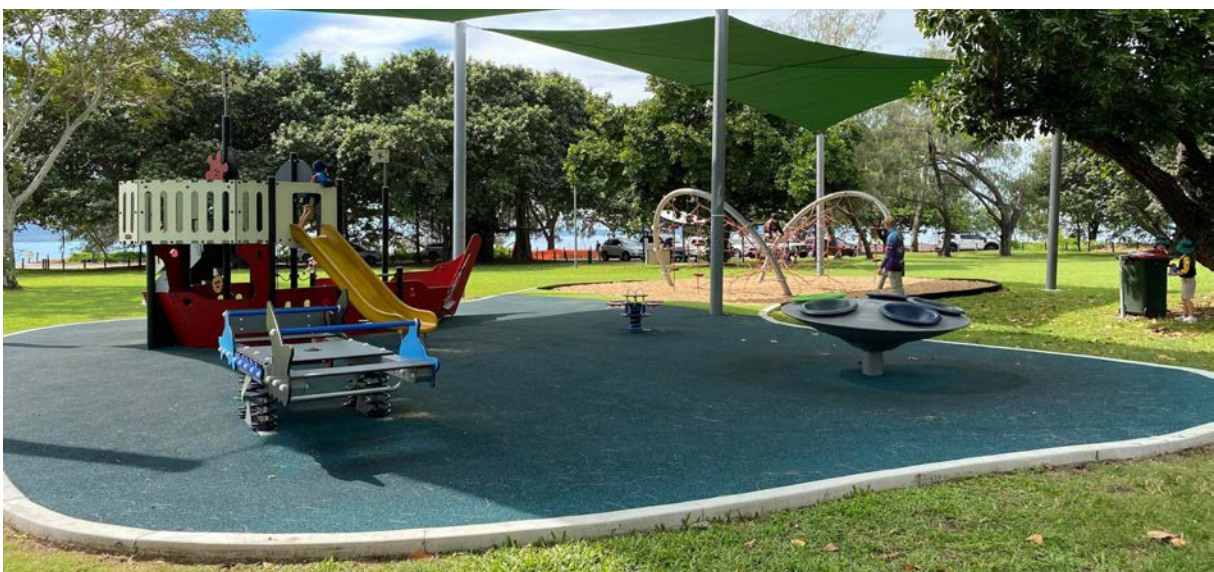
Pallarenda Park main play area is 15 m x 8 m containing a slide and climbing and other play equipment. The area is surrounded by a grass reserve and the beach is approximately 100 m from the play area. The play area has a shade cloth and a blue coloured rubber surface with a concrete edging around the periphery.

Sampling was conducted on the 08/05/2021. No rainfall occurred in the 72 h before sampling. The condition of the play surface was good with the surface relatively new (approximately 2 years old). The grass in the park had recently been mowed. Twelve cores (8 cm diameter x 2 cm depth) were taken at 0 m, 2 m and 4 m away from the play area.

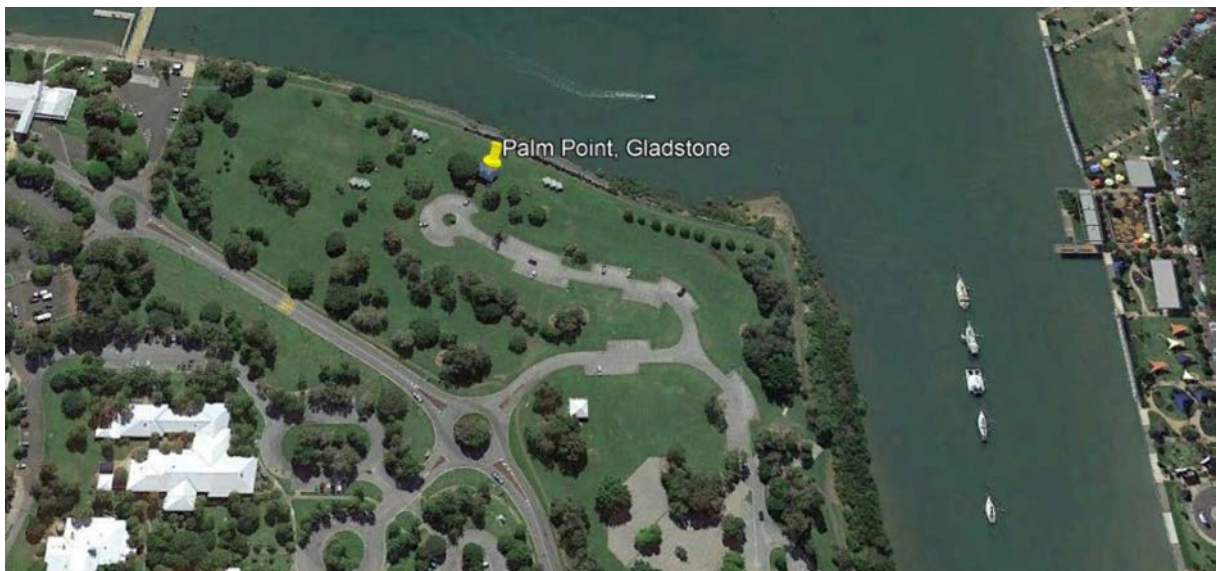
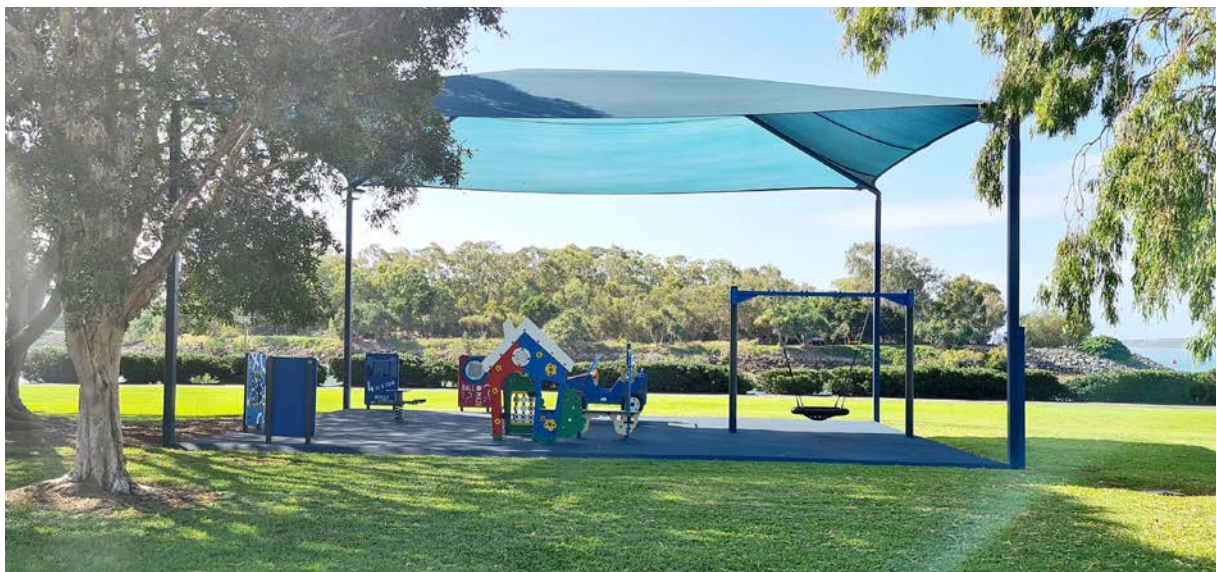
Palm Point Park is located at Gladstone Marina and managed by the Gladstone Ports Corporation. The play area is 22 m x 9 m and has toddlers play equipment (slides and climbing apparatus). The area is surrounded by a grass reserve and the harbour is approximately 24 m from the play area. The play surface is relatively new (3-4 years old) and made up of dark blue coloured rubber.

Sampling was conducted on the 11-12/05/2021. No rainfall occurred in the 72 h before sampling. The condition of the play surface was good with the grounds well maintained. A shade cloth covered the play area and it was a highly visited site for play groups. Twelve cores (8 cm diameter x 2 cm depth) were taken at 0 m, 2 m and 4 m away from the play area.

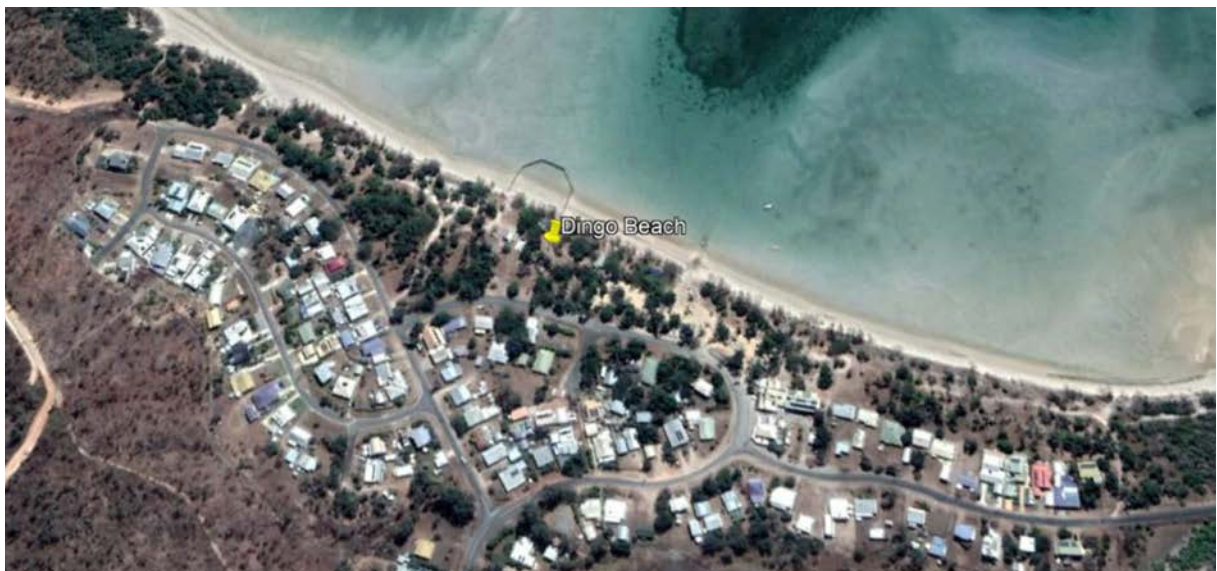
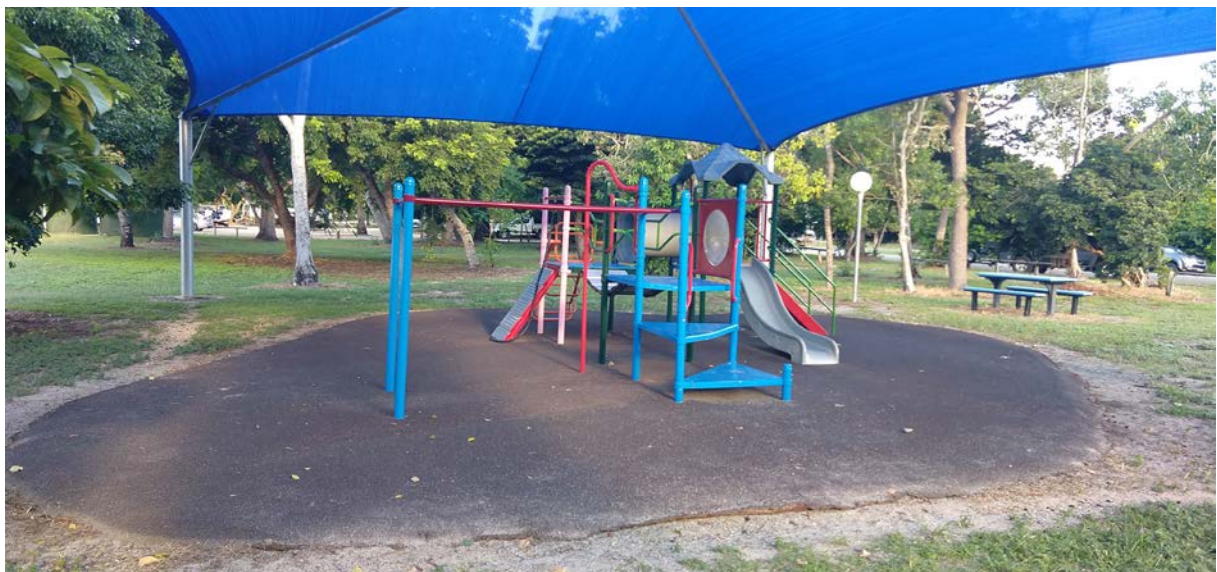
Dingo Beach play area has a circumference of 40 m and contains a slide and climbing equipment. The immediately area is surrounded by sand and grass and the beach is 54 m from the play area. The play surface is of unknown age and made up of a blue, black and terracotta (red) coloured rubber mix.

Sampling was conducted between the 10 - 18/04/2021. Minor rainfall occurred (5-10 mm) in the 72h before sampling. The condition of the play surface was graded as deteriorated with obvious signs of cracking. A shade cloth covered the site. Twelve cores (8 cm diameter x 2 cm depth) were taken at 0 m, 2 m and 4 m away from the play area.
