RUBBER CRUMB LOSS ASSESSMENT FROM PLAY AREAS IN THE GREAT BARRIER REEF CATCHMENT

AUSTRALIAN
MARINE DEBRIS INITIATIVE

November 2021

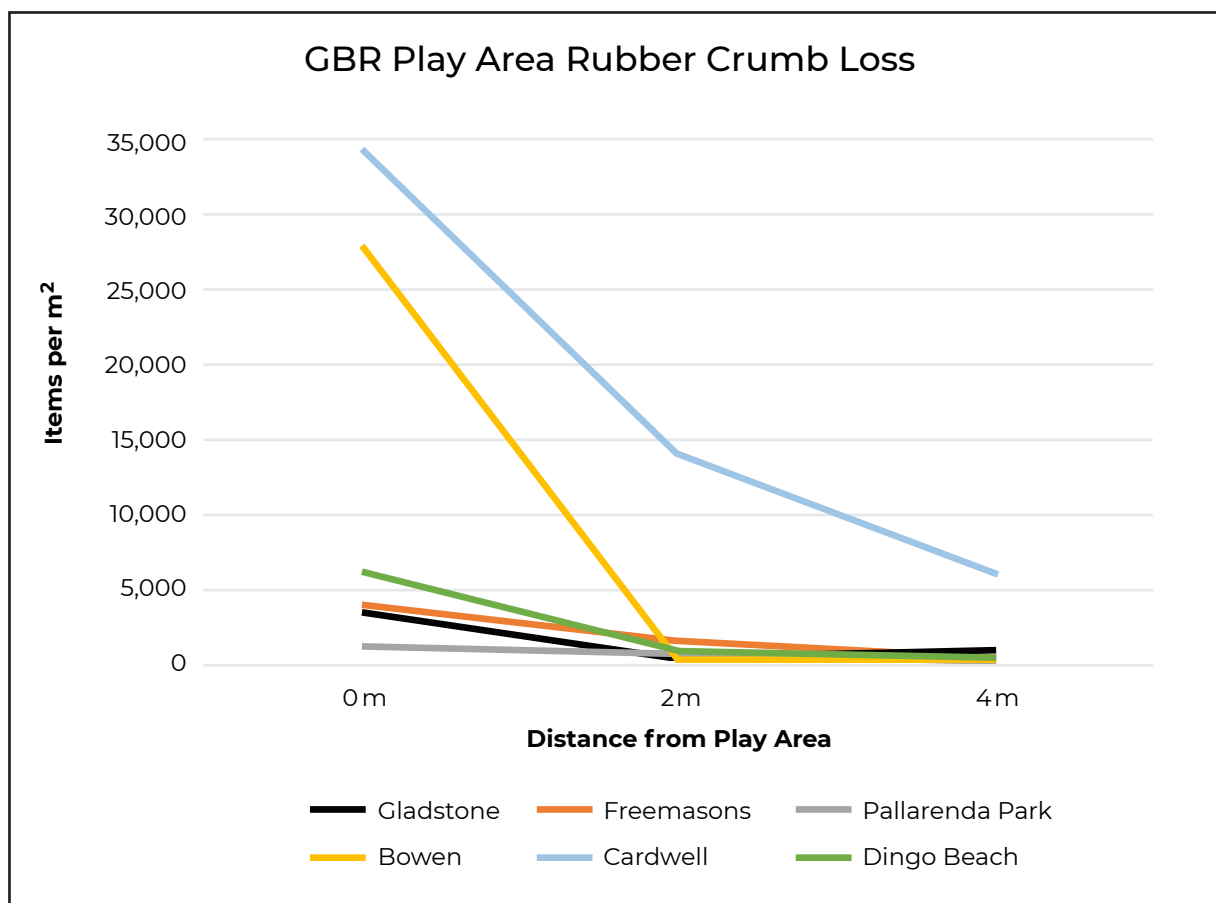
Figure 2: Play area rubber crumb loss at the 6 sites along the GBR

Sampling was undertaken between April and May 2021. Rubber loss was found at all sites with a decreasing trend away from each play area. Mean loss for all GBR sites was 12,890, 3081 and 1404 pieces per m² at 0 m, 2 m and 4 m, respectively (Fig. 2). This implies that for a play area with a 40 m circumference, over 1.2 million rubber crumb pieces are being lost on average out to 4 m, and for some individual sites this would be well over 2.5 million pieces.

The Cardwell and Bowen sites had the greatest rubber loss with levels over 25,000 per m² recorded adjoining the play area. The Pallarenda Park site in Townsville was the newest site studied and recorded the least loss. The age of the surface, the UV exposure, the frequency of use and type of surrounding surface (e.g. grass versus path or bare soil) are factors that can affect both loss and movement from a site.

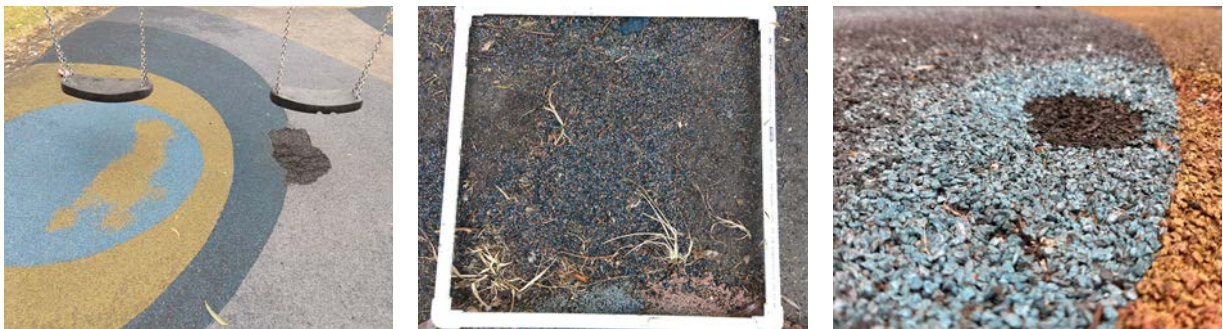
3. GEORGE DAVIDSON PARK RESULTS SUMMARY

Sampling was conducted on the 25/04/2021. Moderate rainfall occurred (13.2 mm) in the 72 h before sampling. The condition of the play surface was graded as deteriorated with obvious signs of damage. The play area has limited shading. Twelve cores (8 cm diameter x 2 cm depth) were taken at 0 m, 2 m and 4 m away from the play area.

- Very high rubber crumb loss close to the play area
- Grass surrounding the play area impedes movement of rubber at further distances away
- Rubber was mostly 1 - 5 mm in size and black (natural) (55 %) or blue (45 %) coloured
- One synthetic fibre was also found.

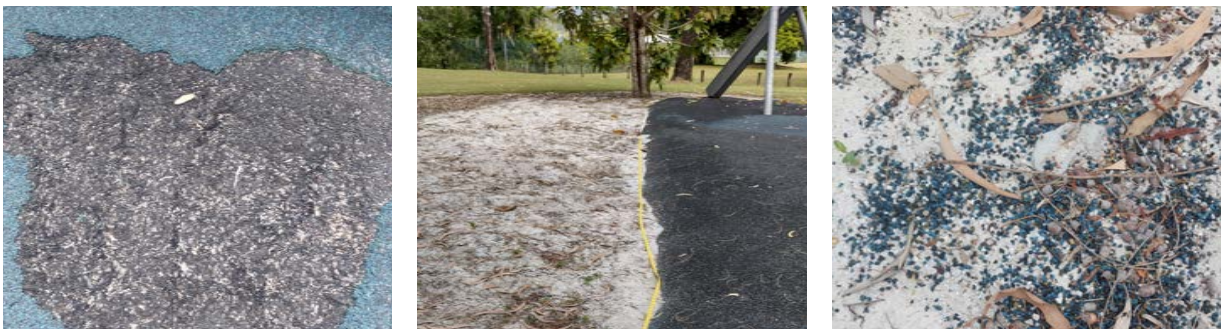
3. CORAL SEA PARK RESULTS SUMMARY

Sampling was conducted on the 30/05/2021. Minimal rainfall occurred (0.2 mm) in the 72 h before sampling. The condition of the play surface was graded as deteriorated with obvious signs of damage. The play area has limited shading. Twelve cores (8 cm diameter x 2 cm depth) were taken at 0 m, 2 m and 4 m away from the play area from the sand/bark/grass areas.

- Very high rubber crumb loss close to the play area
- Very high rubber crumb loss close to the play area and still considerably high amounts were found up to 4 metres from the site
- Sand as a substrate allows movement of rubber at further distances away
- Rubber was mostly 1 – 5 mm in size and blue in colour (68 %). The remainder were black (natural) (32 %).
- No other synthetic micro litter were found.

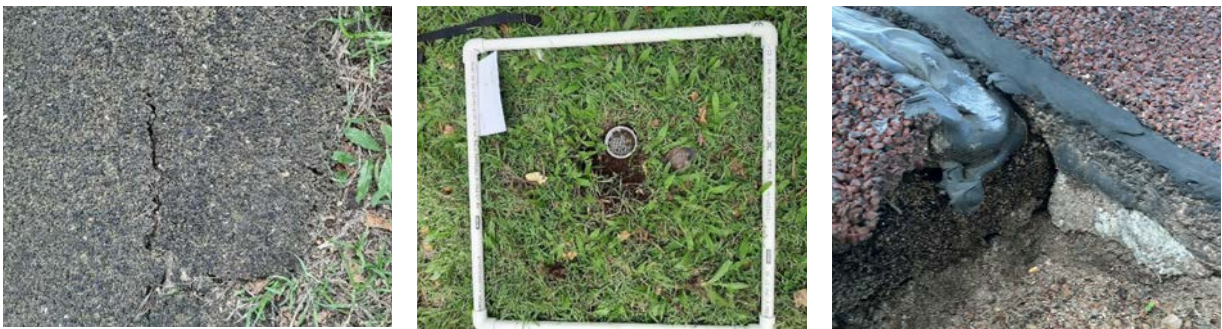
3. FREEMASONS PARK RESULTS SUMMARY

Sampling was conducted on the 17/04/2021. No rainfall occurred in the 72 h before sampling. The condition of the play surface was graded as deteriorated with obvious signs of damage. The play area is part shaded by a large tree. Ten cores (8 cm diameter x 2 cm depth) were taken at 0 m, 2 m and 4 m away from the play area.

- Moderately high rubber crumb loss close to the play area and proportional declines were found up to 4 metres from the site
- Shading may be reducing deterioration rates and grass adjoining the area further limits movement of rubber away
- Rubber was mostly 1 – 5 mm in size and a mix of colours related to the play area (56 % blue, 34 % black, 9.5 % red, 0.5 % green).
- Other micro litter found included two synthetic fibres, one hard fragment and one glass fragment.

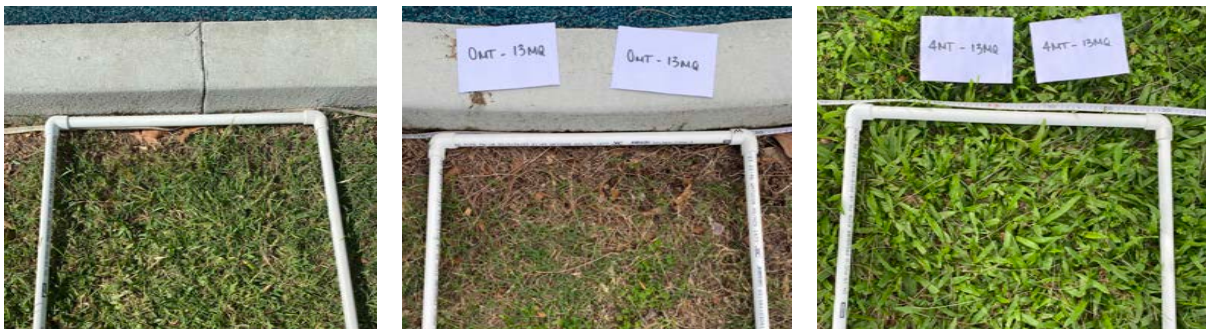
3. PALLARENDA PARK RESULTS SUMMARY

Sampling was conducted on the 08/05/2021. No rainfall occurred in the 72 h before sampling. The condition of the play surface was good with the surface relatively new (approximately 2 years old). The grass in the park had recently been mowed. Twelve cores (8 cm diameter x 2 cm depth) were taken at 0 m, 2 m and 4 m away from the play area.

- Moderate rubber crumb loss close to the play area and proportional declines at distances away from the site
- The new surface and the concrete bunding are likely factors reducing the rubber loss. The shading may also reduce deterioration rates over time
- Rubber was mostly 1 – 5 mm in size and mostly blue (80%) or green (18%)
- A small amount of other microlitter was found including hard fragments, film, fibre, paper and metal.

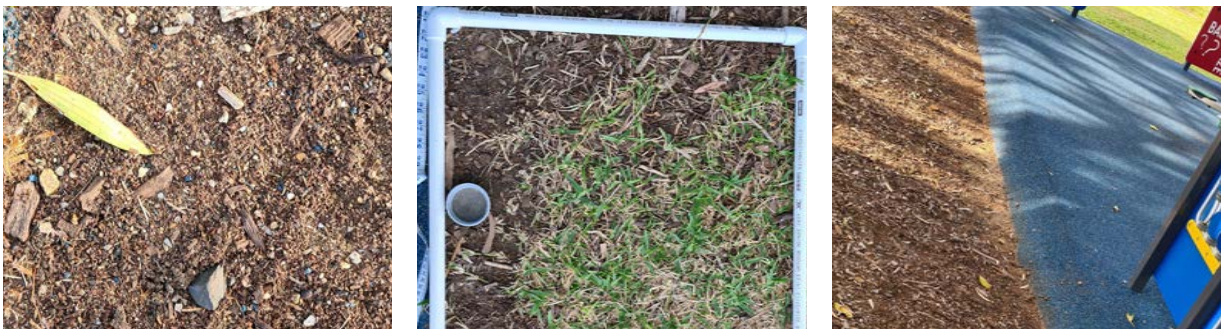
3. PALM POINT PARK RESULTS SUMMARY

Sampling was conducted on the 11-12/05/2021. No rainfall occurred in the 72 h before sampling. The condition of the play surface was good with the grounds well maintained. A shade cloth covered the play area and it was a highly visited site for play groups. Twelve cores (8 cm diameter x 2 cm depth) were taken at 0 m, 2 m and 4 m away from the play area.

- Moderate rubber crumb loss close to the play area and declines at distances away from the site, although rubber was higher at 4 m than 2 m. This is possibly due to the microtopography of the site, where depressions allow more rubber to settle.
- Despite heavy use, the relatively new surface is a likely factor in lower rubber crumb loss at this site. The shading may also reduce deterioration rates over time
- Rubber was mostly 1 – 5 mm in size and was predominantly blue (98%)
- A small amount of other microlitter was found including hard fragments, fibre, and glitter.

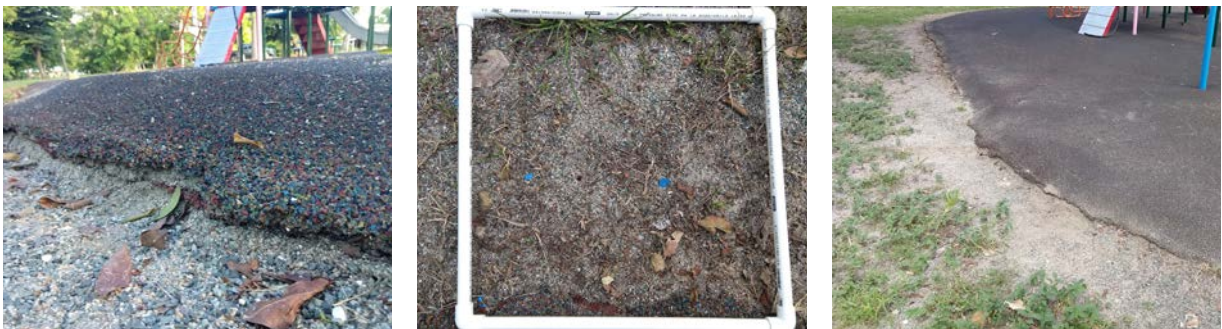
3. DINGO BEACH RESULTS SUMMARY

Sampling was conducted between the 10 - 18/04/2021. Minor rainfall occurred (5-10 mm) in the 72h before sampling. The condition of the play surface was graded as deteriorated with obvious signs of cracking. A shade cloth covered the site. Twelve cores (8 cm diameter x 2 cm depth) were taken at 0 m, 2 m and 4 m away from the play area.

- Moderately high rubber crumb loss close to the play area and proportional declines at distances away from the site
- Shading may be reducing deterioration rates and grass adjoining the area further limits movement of rubber away
- Rubber was mostly 1 – 5 mm in size and a mixture of blue, black, red and yellow colours
- A small amount of other microlitter was found including hard fragments, synthetic fibres, glass and metal.
